Case study: Side and rear extension, Purley Croydon.

Architects: CBS

· Project value: £180k

Duration- 20 Weeks

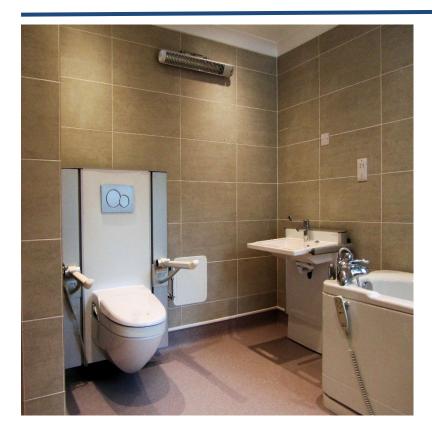
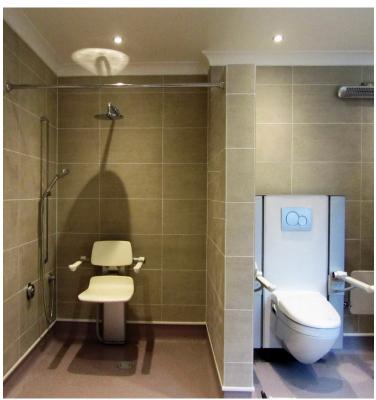
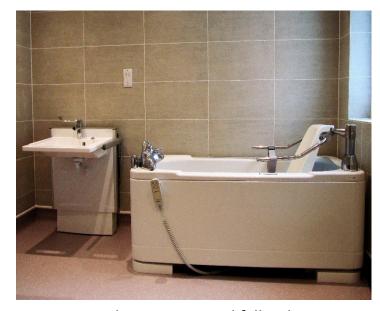
Images showing rise and fall toilet, shower area, basin and bath tub.

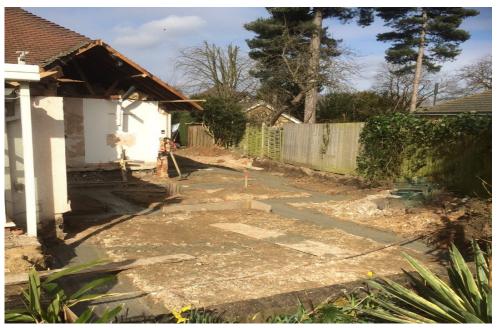
Demolition work completed, the oversite excavated to formation level and concrete strip foundation made ready for brickwork.

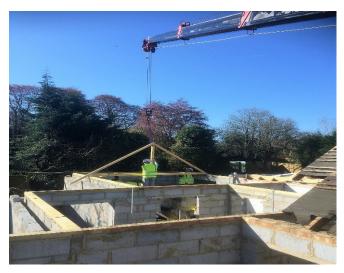
Blockwork in cavity to wall plate height. Timber truss roof was manufactured off site, craned into place and installed quickly and easily in one day.

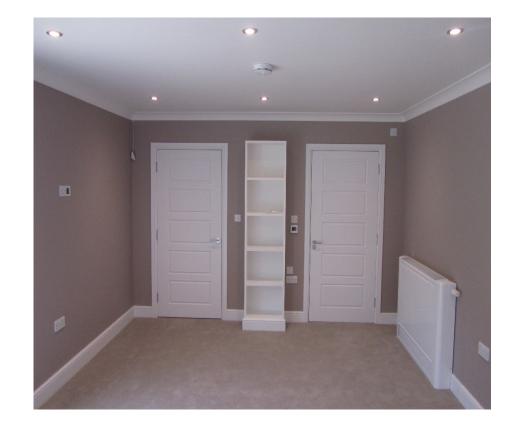
Child's bedroom fitted with low surface temperature radiator, remote control window actuators and level access threshold onto decking area.

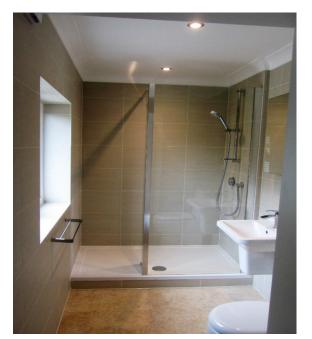
Carers en-suite shower room with fully fitted shower room suite, high quality vinyl flooring and electric under floor heating.
